BALTCF project 051S17 „Freshwater health control through Black Stork perspective”

Assessment of Black Stork (*Ciconia nigra*) feeding streams 2020-2021

REPORT

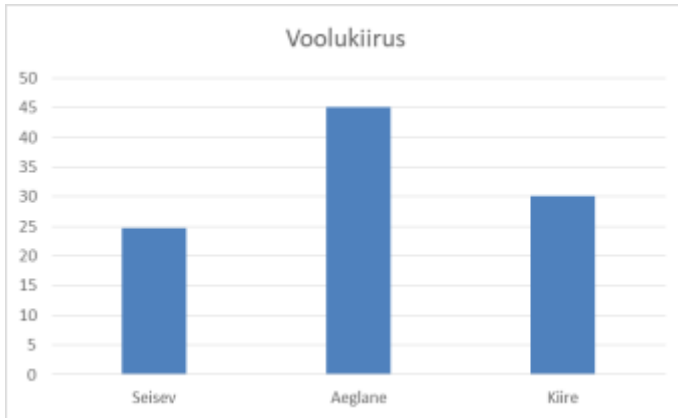
The flow rate of the studied water bodies could be assessed on a three-point scale (if there was water in them; Figure 5) and several values could be given if the flow rate varied in different parts of the section. Overall, standing water accounted for 25 percent of the ratings, slow current 45 percent, and fast current 30 percent. Four percent of the total sample were dry at the time of description, they are not considered when describing water-related parameters.

Figure 5. Flow rate in described water bodies (n=761). From left to right: still; slow; fast.

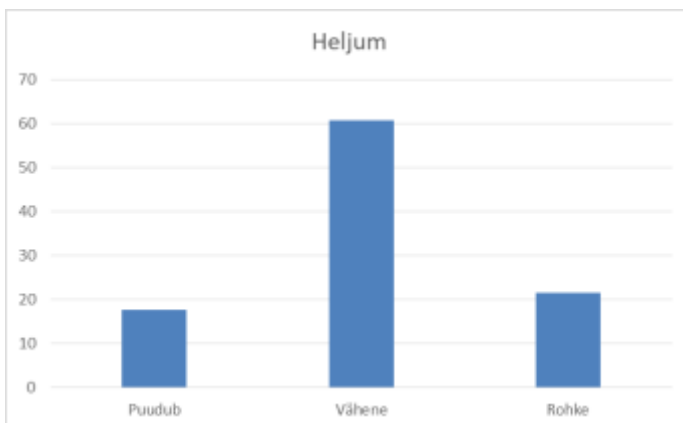
In terms of the content of suspended solids (under normal conditions), the described waterbodies are rather poor, the content of suspended solids was high in one fifth of the waterbodies (21%), in the remaining water bodies it was low (61%) or absent altogether (18%; Figure 7).

Figure 7. The content of suspended solids in the described waterbodies under normal water conditions (n=891). From left to right: missing, somewhat, a lot.

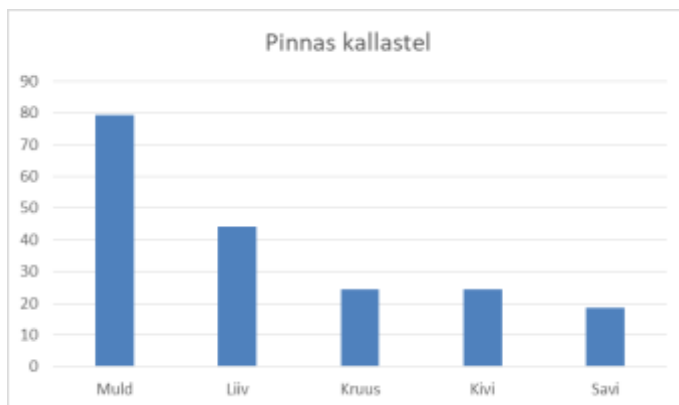
Figure 9. Visible soil on the banks of the described water bodies (n=1830). From left to right: soil, sand, gravel, stones, clay.

The banks of the water bodies were mostly high (64%; Figure 8), the visible soil on the banks was mainly soil (n=762; 42%) and sand (n=423; 23%), there were less gravel, stony and clay bank sections (Figure 9).

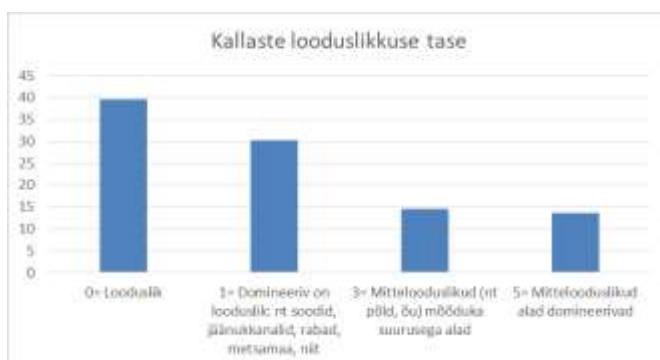
During the inventory, the level of naturalness of the habitats found on the banks of the described water bodies was also assessed. Mostly, the described water bodies were in natural (40%) or mostly natural habitats (30%). Non-natural habitats/surroundings were moderately present in nearly 14 percent of the sections, and non-natural surroundings were predominant in nearly 14 percent of the sections as well (Figure 10).

Figure 10. The level of naturalness of habitats found on the banks of water bodies (n=940). 0= natural, 1= dominantly natural, 3= moderately non-natural banks, 4= non-natural areas are dominating.

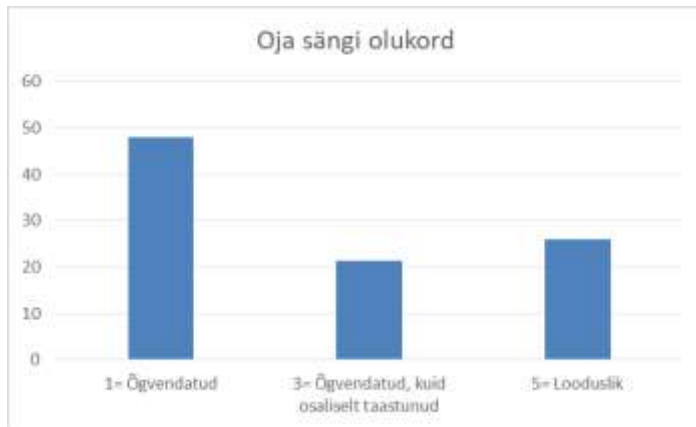
Almost 2/3 of the described sections were straightened and deepened, but according to the observers, about a third of them (21 percent of all sections) had started to recover their natural appearance. 26 percent of the described sections flowed in a completely natural bed or a bed with a natural appearance changed a very long time ago (Figure 11).

Figure 11. The level of naturalness of the flow bed (n=913). 1= straightened, 3= straightened, but partly recovered, 5= natural conditions.

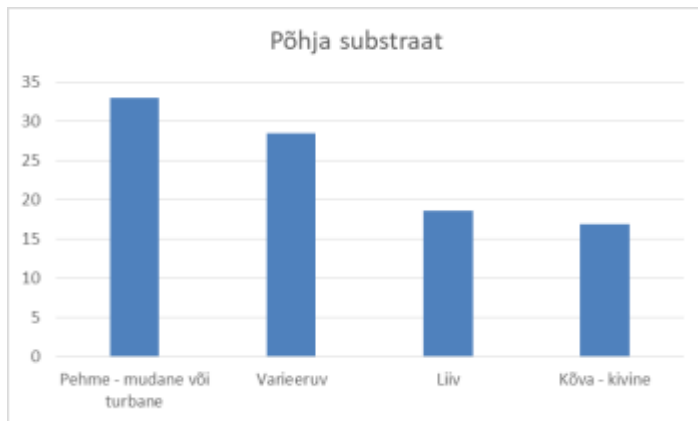
The bottom substrate of the water bodies was soft in a third of the sections (muddy or peaty, 33%). The remaining sections (2/3) were suitable for the black stork to feed on: 28 percent had variable bottom sections, 19 percent and 17 percent were mostly sandy and rocky sections, respectively (Figure 13).

Figure 13. The nature of the bottom substrate (n=929). From left to right: soft, variable, sand, hard.

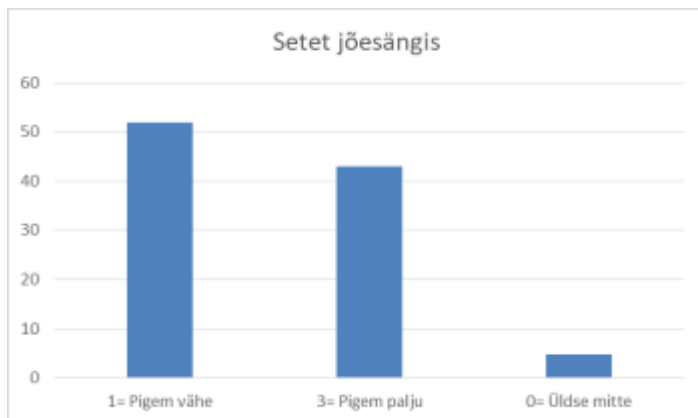
According to the amount of sediment accumulated in the riverbed, the water bodies were roughly divided into two according to visual assessment - in more than half of the sections there was rather little (52%) or no sediment (5%), in the remaining sections (43%) there was rather a lot of sediment (Figure 14).

Figure 14. The amount of sediment accumulated in the stream bed (n=956). 1= rather small amount, 3= rather a lot, 0= not at all.

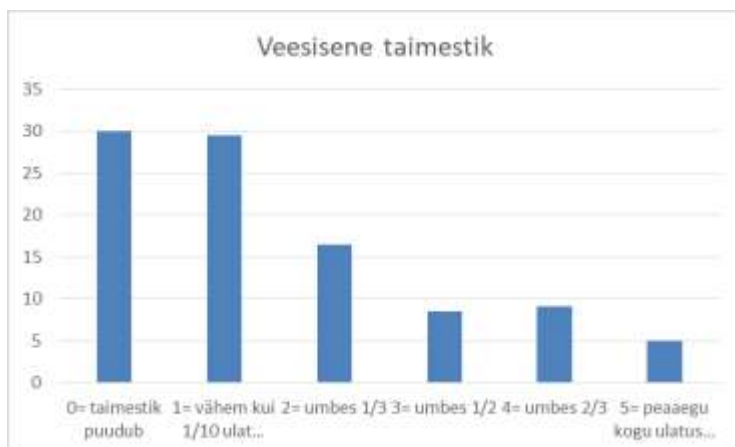
As most of the sections were shadowed (Figure 15), many sections also lacked aquatic vegetation (30%) or had little cover (30%). One-third to one-half of the bottom of the water body was covered by vegetation in 25 percent of the sections, 15 percent of the sections were mostly or completely vegetated (Figure 16).

Figure 16. The coverage of aquatic vegetation in the assessed sections (n=946). 0= missing, 5= almost everywhere.

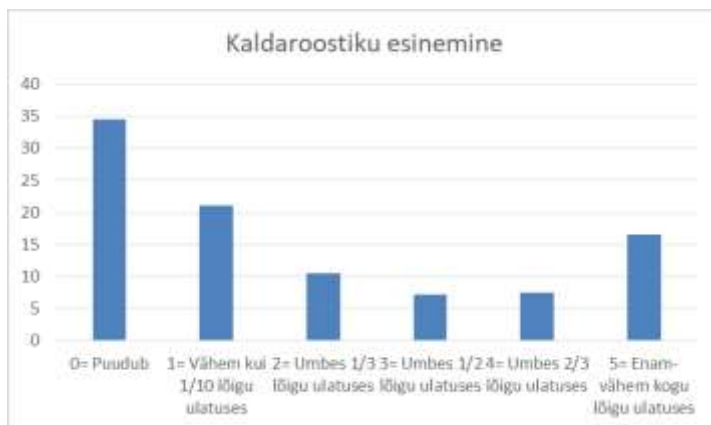
Reed was present in almost 2/3 of the inventoried sections, although in 21 percent of these sections the species was rather random (occurred in 1/10 of the sections). 24 percent of the sections were completely or mostly full of reeds, 35 percent of the sections were not reedy (Figure 18).

Figure 18. The presence of riparian reeds in the described sections (n=935). 0= missing, 5= almost everywhere.

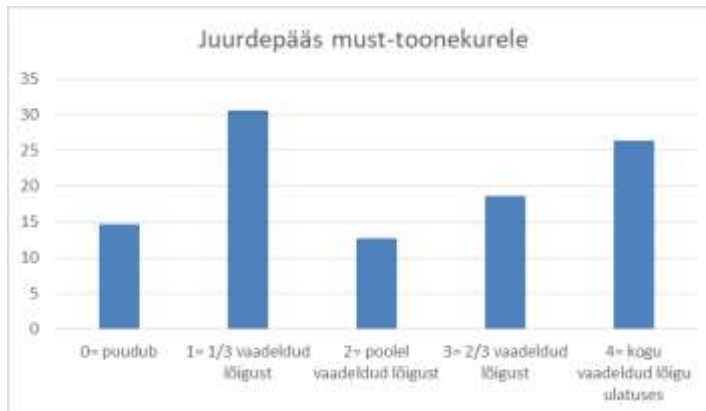
Observers of water bodies assessed the accessibility of the water body from the point of view of the black stork - whether the water body is accessible from above or approached from the riverbanks, whether the stork can walk and fly along the stream or ditch. According to this evaluation, 14 percent of the sections were inaccessible to black storks, 30 percent were partially (1/3) open. The remaining 56 percent of the water bodies were open to birds from half to the whole extent (Figure 21).

Figure 21. Black stork access to the described sections (n=987). 0= missing, 2= half of the section is accessible, 4= accessible along the whole section.
